DTIC FILE COPY
Special Report 88-17

US Army Corps
of Engineers

*Effects of all-terrain vehicle traffic
on tundra terrain near Anaktuvuk Pass, Alaska*

Prepared for
BUREAU OF INDIAN AFFAIRS

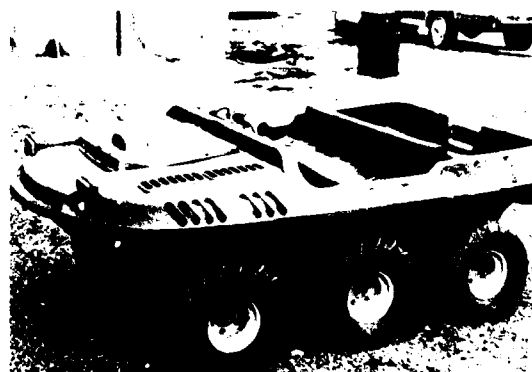
Figure 1. All-terrain vehicles in use at Anaktuvuk Pass, Alaska.

a. Eight-wheel Argo (left) and four-wheel all-terrain cycle (right).

b. Argo six-wheel ATV. Note the two types of tires.

The great majority of the vehicles using these trails in 1985 and 1986 were the amphibious Argo six- or eight-wheel ATV manufactured by Ontario Drive and Gear in Ontario, Canada (Fig. 1). All six or eight wheels are driven by a chain drive over a fixed axle. In 1985 about 50 of these vehicles were owned by the 200–250 residents of Anaktuvuk Pass. Although the three- and four-wheel all-terrain cycles are common in Anaktuvuk Pass, these are used mainly within the village. The Argo weighs 400–600 kg, is 1.6 m wide with 20 cm of ground clearance, and has low-ground-pressure (0.1 kg/cm^2) tires (usually the Runamuck tire) with shallow cleats (Fig. 1). The Argo can carry two to six passengers or up to 540 kg. A single trip may consist of 30–60 km using one tank (30 L) of fuel (Table 1). The average traveling speed is probably 15–30 km/hr (Gerlach and Hall 1985).

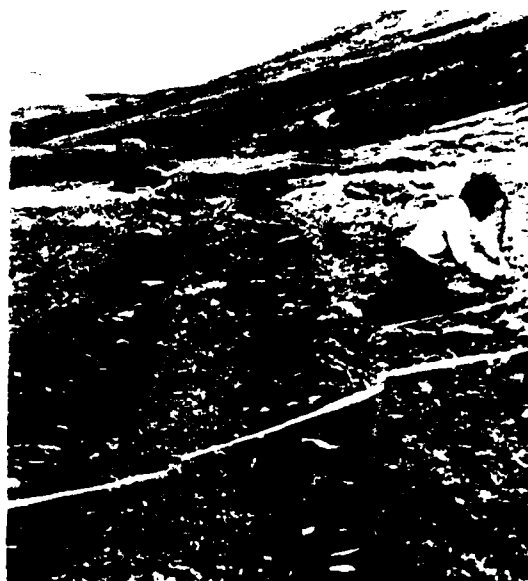
a. Trail with a moderate level of disturbance.

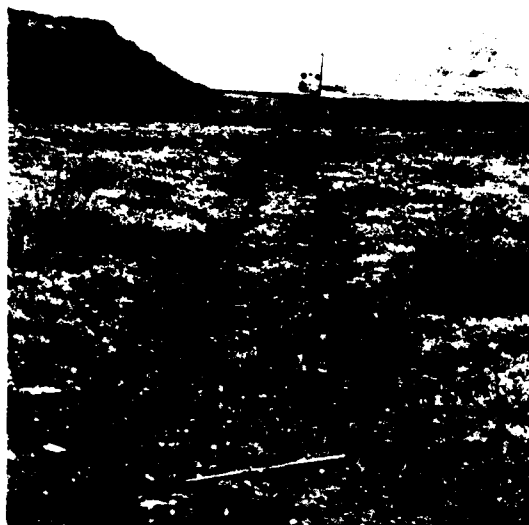
c. ATV trail over dry tundra on an old river terrace with a low disturbance rating. Note the suppression of flowering of *Oxytropis borealis* in the tracks.

On better-vegetated old river terraces with high moss cover and taller shrubs of birch or willow, terrain disturbance was generally low. The moss cover here is resistant to damage, but the taller shrubs are broken, and in dense shrub-covered flood plains, the shrub cover can be completely destroyed. Such trails may be highly visible from the air. The flowering of some flood-plain species (*Oxytropis borealis*) may also be disrupted by the traffic, increasing trail visibility (Fig. 8c).

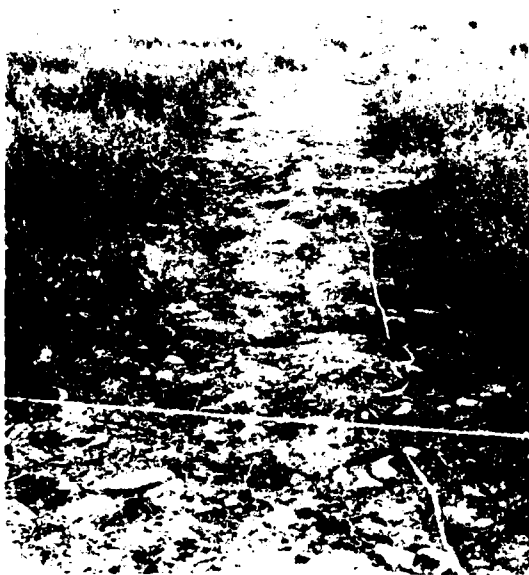
d. Moderate level of terrain disturbance over dry tundra trail on an older flood plain. Vegetation disturbance is high because of the loss of low birch shrubs.

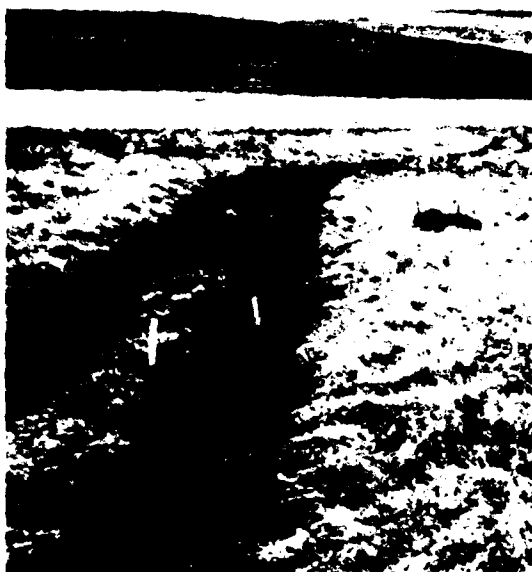
a. High level of terrain disturbance on an ATV trail over moist tussock tundra.

track (Fig. 9a). Trail widths here may reach 3–8 m.

The five moist tundra sites with high levels of terrain disturbance were all highly visible (Fig. 9a). The other trails were slightly visible on the ground and only barely perceptible from the air (Fig. 9b).

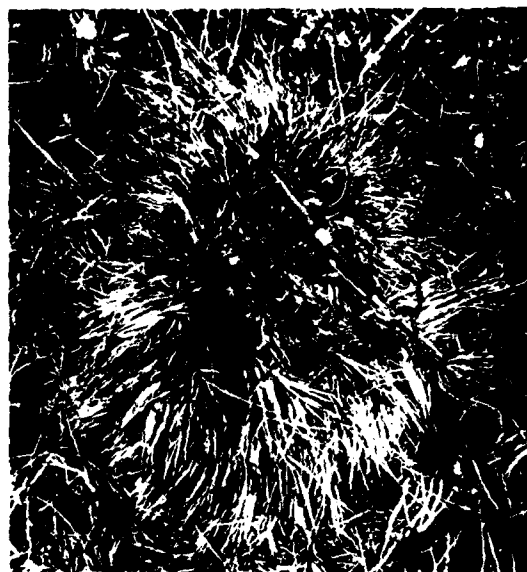
c. Cottongrass (*Eriophorum vaginatum*) tussock damage on an ATV trail showing compression and tearing of tillers.
